Cannon River Watershed Monitoring and Assessment Report

Document number: wq-ws3-0704002b

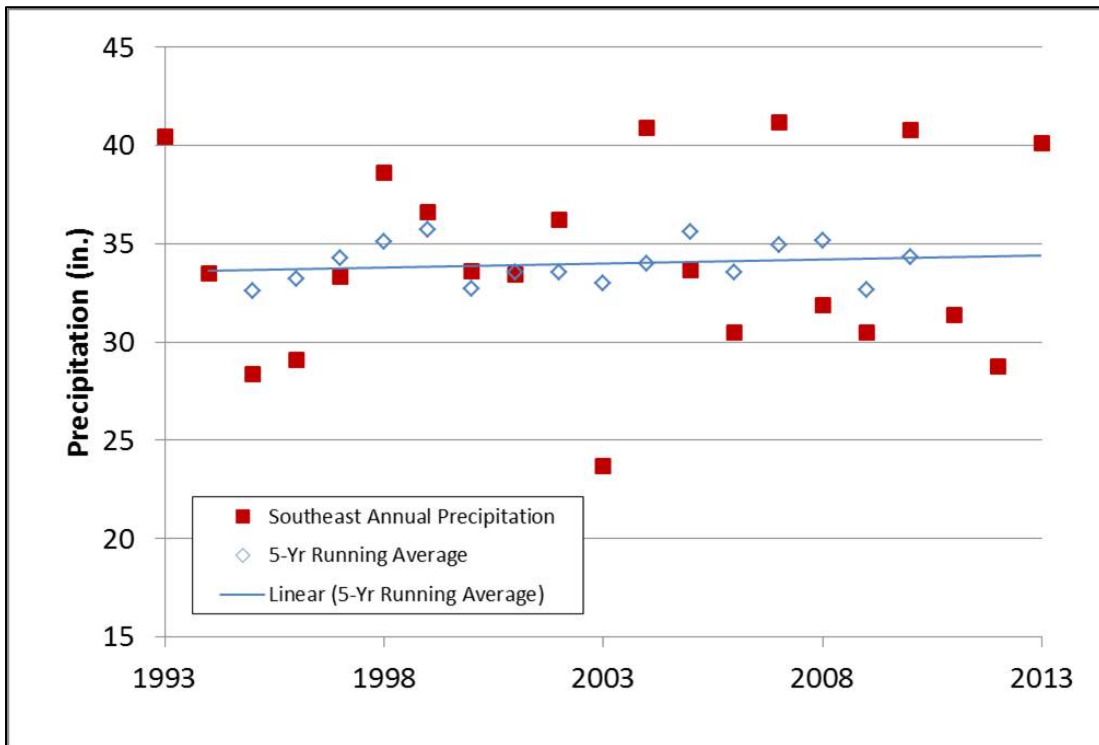
Figure 15. Precipitation trends in southeast Minnesota (1993-2013) with five-year running average.

Figure 15 displays the areal average precipitation in southeast Minnesota. An areal average is a spatial average of all the precipitation data collected within an area presented as a single dataset. These data are taken from the Western Regional Climate Center, available at the University of Minnesota Climate website: <http://www.wrcc.dri.edu/spi/divplot1map.html>. Though it can vary in intensity and time of year, rainfall in the southeast region has not risen significantly over the last 20 years.

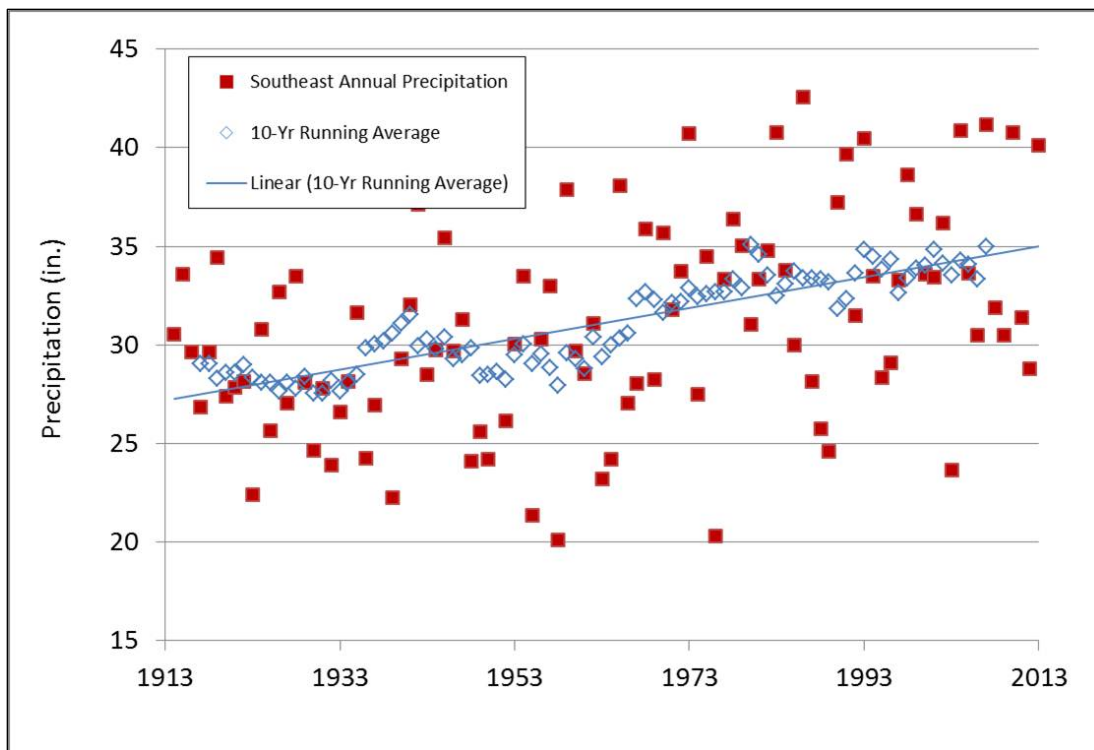
Figure 16. Precipitation trends in southeast Minnesota (1913-2013) with 10-year running average.

In contrast, precipitation in southeast Minnesota exhibits a statistically significant rising trend over the past 100 years ($p=0.001$, Figure 16). This is a strong trend and matches similar trends throughout Minnesota.

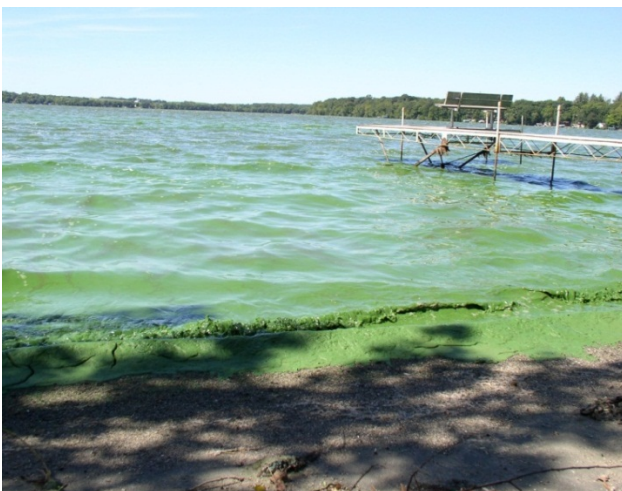
Image 1: Green algae on Roberds Lake. (8/9/2004). Photo by CRWP.

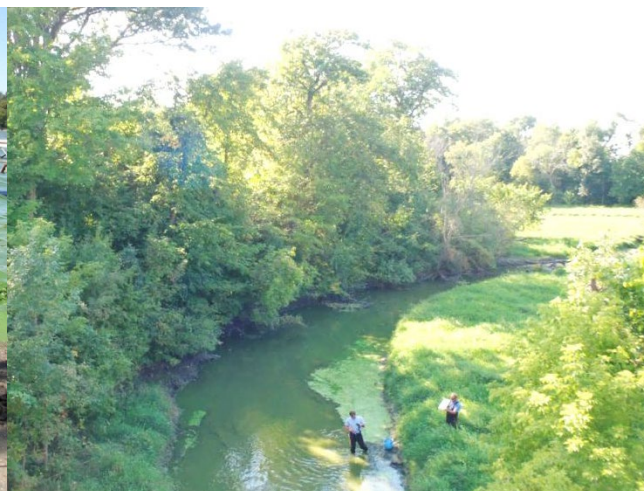
Image 2: Cannon River near the headwaters at station 11LM095. (9/12/2011)

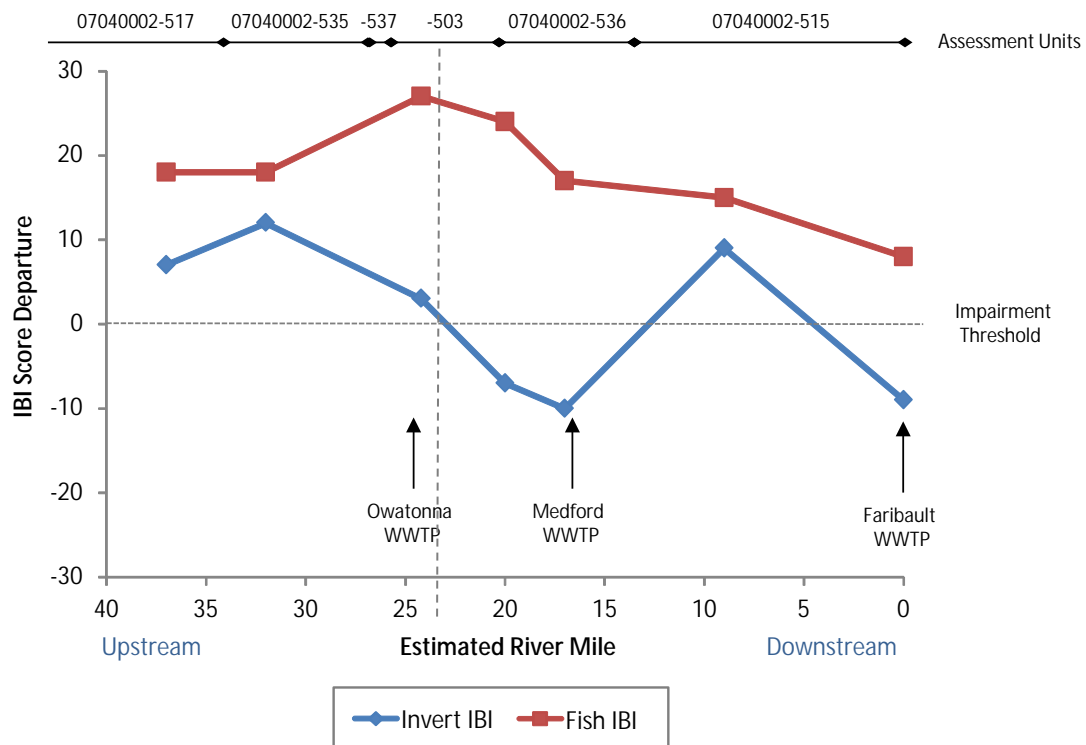
Figure 24. Longitudinal pattern of fish and macroinvertebrate IBI scores (2010 & 2011 data) along the Straight River (dotted line divides the reaches into Upper and Lower Straight River Subwatersheds). To standardize the comparison between the two assemblages and among the monitoring locations, scores are depicted as departures from the impairment threshold because multiple IBI classes (each calibrated independently) are represented.

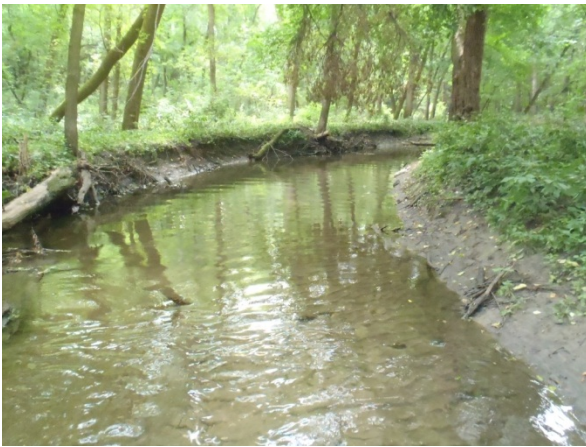
Image 3: Cut banks and excess sedimentation creating uniformly shallow water depth at 11LM022, a tributary to Maple Creek.

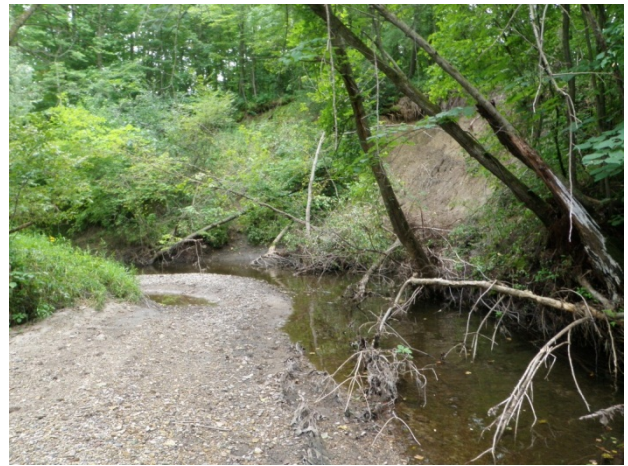
Image 4: Aggradation on point bar causing flow-deflection and erosion on outside bank at 11LM069 on Falls Creek.

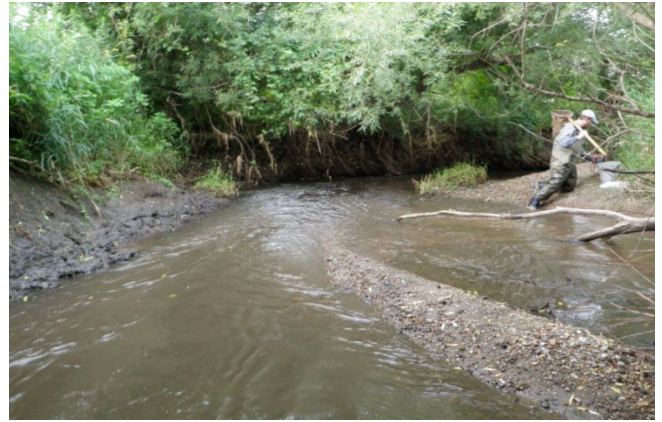
Image 6: Evidence of channel instability as bank erosion and mid-channel bars at 11LM008 on unnamed creek.

The other reach that is fully supporting aquatic life (unnamed creek -525) is a 12 mile long tributary to the Straight River. There were three biological stations sampled in 2011. The macroinvertebrate community scored above the impairment threshold at all three stations. However, for fish, while the two lower stations (11LM008 and 11LM039) scored well above the impairment threshold with high diversity of species (15 and 29, respectively) and sensitive taxa present, the fish community at the upstream station (11LM036) scored 10 points below threshold with low species diversity (7) and only one sensitive individual (Iowa darter) collected. Habitat was rated good with gravel and cobble riffles and light embeddedness in runs. Channel stability was rated fairly stable with some bank cutting observed. Given the good ratings for macroinvertebrates and that there was nothing noted that would be considered a biological stress to the fish community, the assessment team assessed the reach as fully supporting. Pictures from sampling indicate that although this reach is fully supporting for both fish and macroinvertebrates, some moderate channel instability is occurring at the lower stations (11LM008, 11LM039). CCSI scores and site images from these two stations indicate that the stream is moderately incised with severely cut banks (i.e., flow related bank erosion). This may be a symptom of watershed-wide changes in hydrology that have caused streams to down-cut and concentrate flows within the stream channel during high flow events, thereby scouring substrates and eroding banks (Image 6).

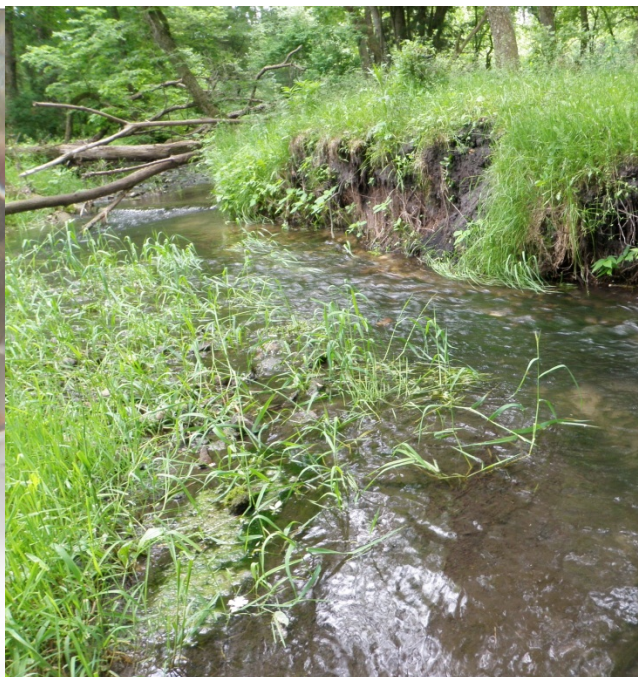
Image 9: Cut banks and filamentous algae in-stream on Spring Brook (Rice Creek) during sampling in 2011.

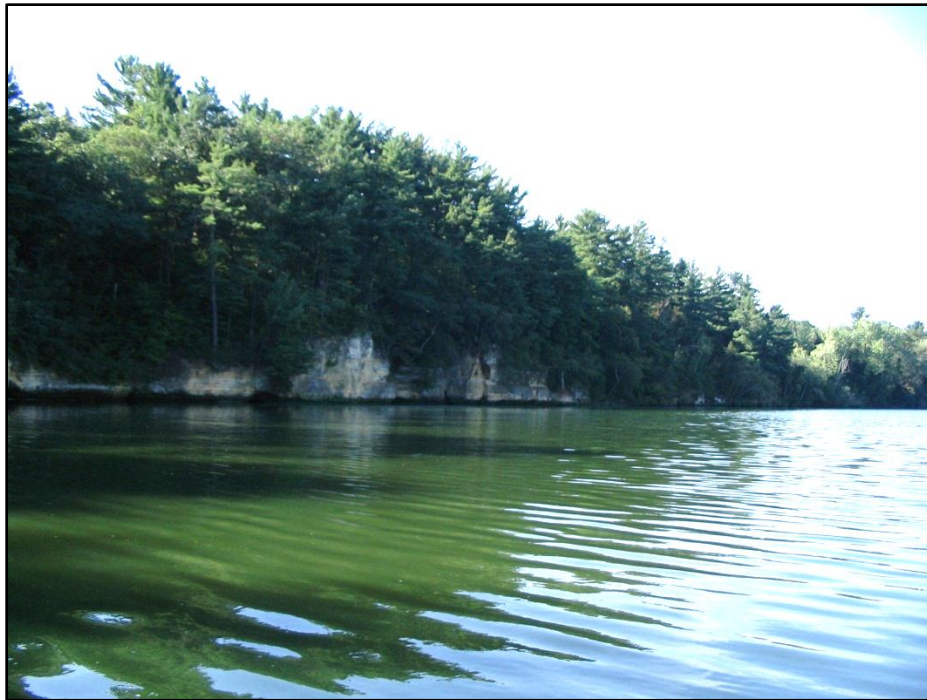
Image 10: Algae bloom on the Byllesby Reservoir (9/5/2008). Image by CRWP.

Of the seven basins >10 acres in size, only one (Byllesby Reservoir, 19-0006) was assessed for aquatic recreation use support. The Byllesby Reservoir is located in the NCHF ecoregion but has site specific standards more akin to the WCBP ecoregion. The reservoir is a flow-through lake with its deepest parts found in the old channel of the Cannon River just before reaching the dam. Most of the reservoir is shallow and susceptible to internal nutrient loading, driven by wind action mixing the water column and re-suspending nutrients in the bottom sediments which makes it prone to algal blooms (Image 10). The Byllesby Reservoir was listed as impaired for aquatic recreation use due to excessive nutrients in 2002. That impairment is confirmed by the most recently available data (Table 43) showing phosphorous concentrations more than double the site specific eutrophication standard of 90 µg/L. The Byllesby Reservoir is also not supporting aquatic consumption due to elevated mercury in fish tissue. Guidelines for eating fish from this lake can be found on the MDH website:

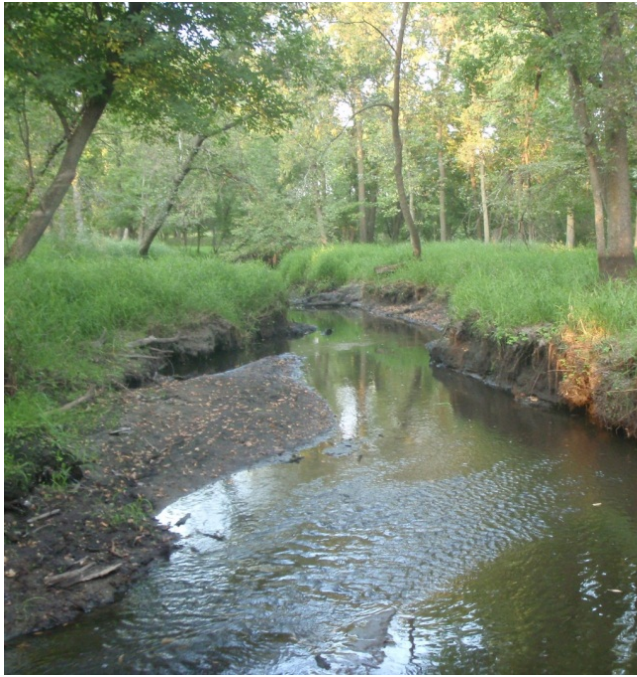
Image 11: Cut banks and excess deposition indicating an incised and overwidened stream at 04LM076 on Heath Creek (8/5/2013).

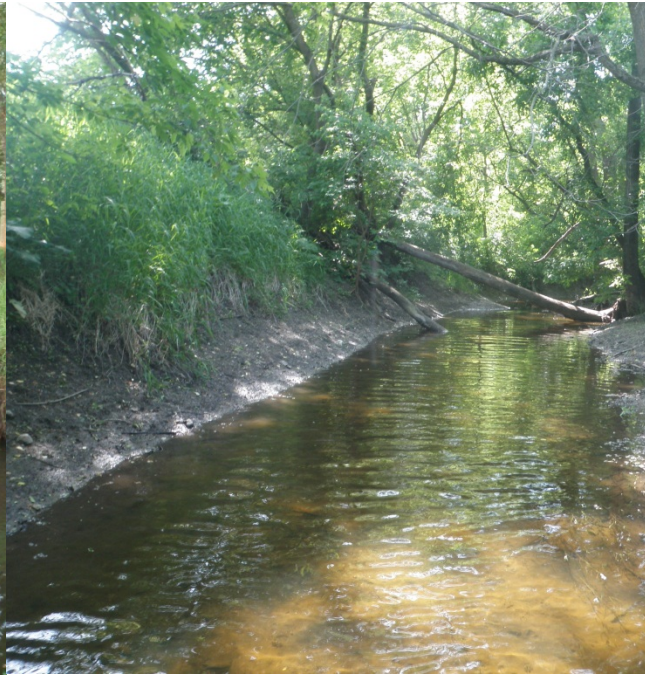
Image 12: Incised banks and shallow run filled with silt on Knowles Creek (June 13, 2011).

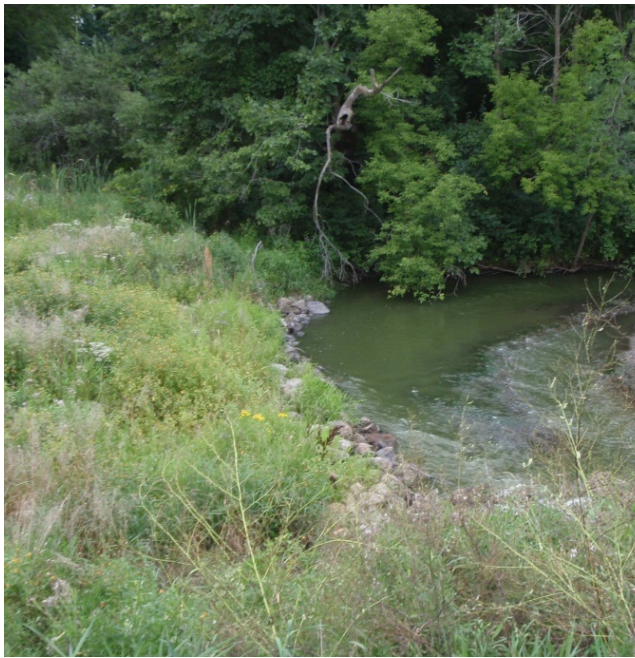
Image 13: Green cast to water due to algae observed on Wolf Creek (8/6/ 2011).

Wolf Creek (-522)-- from Circle Lake to the Cannon River-- was listed as impaired for aquatic life use due to turbidity in 2006, and this impairment was confirmed with more recent data. At the outlet station (11LM003), the water typically has a very green cast, especially during late summer (Image 13), indicating a potential nutrient issue. There are two water chemistry stations on Wolf Creek, one upstream and one on the downstream end of the reach. When sampled on the same date, transparency (water clarity) was typically less at the upstream reach than at the downstream station which may be due to the proximity to Circle Lake to the upstream site, which is impaired due to excess phosphorus which may be fueling algae growth in Wolf Creek. Some phosphorus may have been attenuated in the downstream site or it has less light for algae growth. Currently, the fish and macroinvertebrate communities in the lower section of Wolf Creek (below Circle Lake) are meeting their expectations for a healthy stream. However, a comparison of IBI scores to each assemblage's impairment threshold reveals that both communities are only barely meeting these expectations. Except for dominance by one species, the common shiner, the fish community was fairly well balanced with good numbers of individuals representing sensitive species (e.g., hornyhead chub, longnose dace). For macroinvertebrates, Wolf Creek is one of only two locations in the Cannon River Watershed where the pollution-sensitive, turtle shell case-maker caddisfly larvae, *Glossosoma sp.*, was collected. Due to the IBI scores for both biological assemblages being near the threshold of impairment, it will be important to address existing impairments in both the creek itself (turbidity) and the lake immediately upstream (Circle Lake – excess nutrients & fish tissue mercury impairments) to maintain and improve the aquatic life of Wolf Creek.

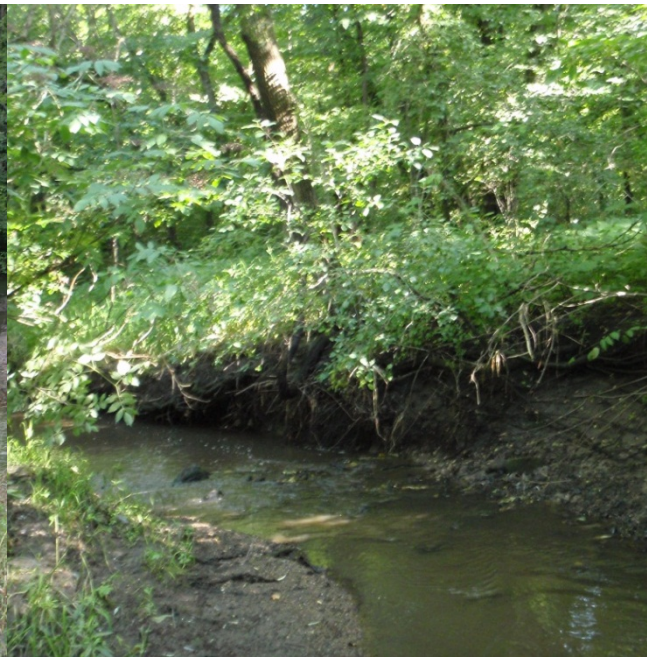
Image 14: Cut banks on Wolf Creek at 04LM084 in 2011.

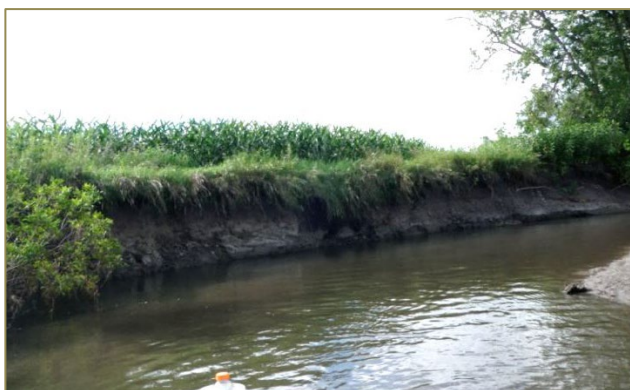
Image 15 : Severely cut banks along outside bend on the Little Cannon River.

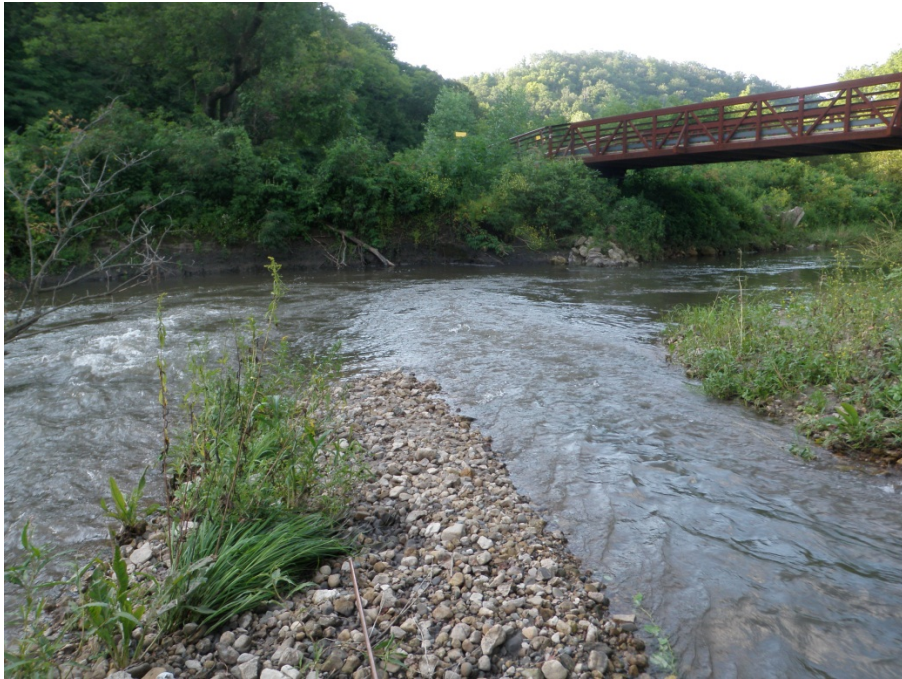
Image 18: Lateral riffle deflecting flow into the outer bank by new ATV bridge on Belle Creek. Image taken on August 4, 2011 before large storm event and high flows caused more severe bank erosion in fall 2011 and 2012.

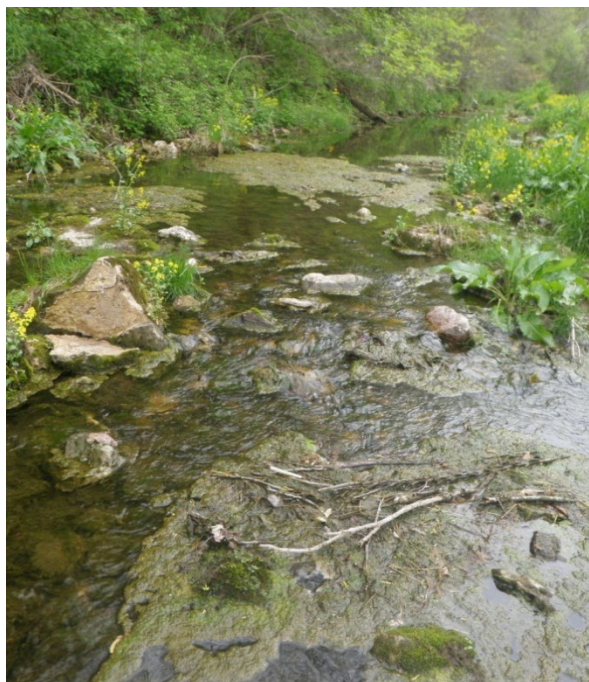
Image 19 : Dense algae in 2011 at station 99LM005 (tributary to Trout Brook).

(99LM005) on an adjacent tributary, nitrates were slightly lower at 11 mg/L. This difference in nitrate concentrations in these two branches of Trout Brook is puzzling. Biological monitoring data collected from both stations on the western branch (04LM144) and eastern branch (99LM005) yielded M-IBI scores below the impairment threshold for southern coldwater streams. While both branches of Trout Brook have extremely high nitrate concentrations, the eastern branch is showing signs of eutrophication (i.e., dense filamentous algae, Image 19) to a much greater extent than the western branch. This is likely due to the relatively sparse forest canopy along the eastern branch's riparian corridor allowing more sunlight to reach the water's surface. Recent flooding in 2012 has further degraded the riparian canopy (Image 20). Both of these upper stream reaches had significantly fewer mayfly and caddisfly species collected compared to the station further downstream (99LM001) where the M-IBI score was above the impairment threshold. Since nitrate concentrations are equally high in the unimpaired downstream reach, it appears that macroinvertebrate impairments in the upper reaches are not exclusively due to the toxic effects of this pollutant. This reach on Trout Brook was also listed due to turbidity in 2006 although more recent data suggest that this stream is now meeting the standard; however, additional data are needed with which to propose a delisting for turbidity.

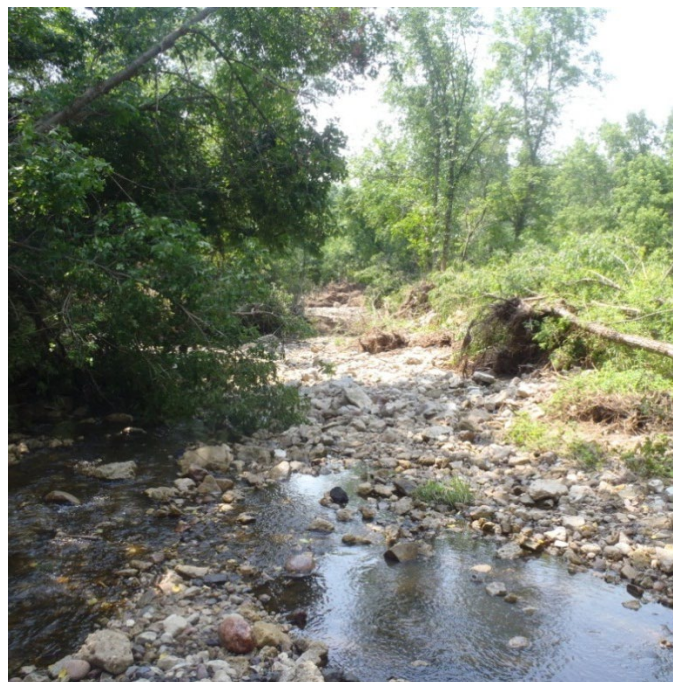
Image 20: Station 99LM005 after severe flooding in 2012.
